A REPORT ON NONDESTRUCTIVE TESTING AND STRUCTURAL ANALYSIS ON ELEVEN IRON CASEMATE CARRIAGES AND CHASSIS

FORT SUMTER NATIONAL MONUMENT

April 2, 1979

LEE WAN and ASSOCIATES, INC.
engineers / architects / surveyors

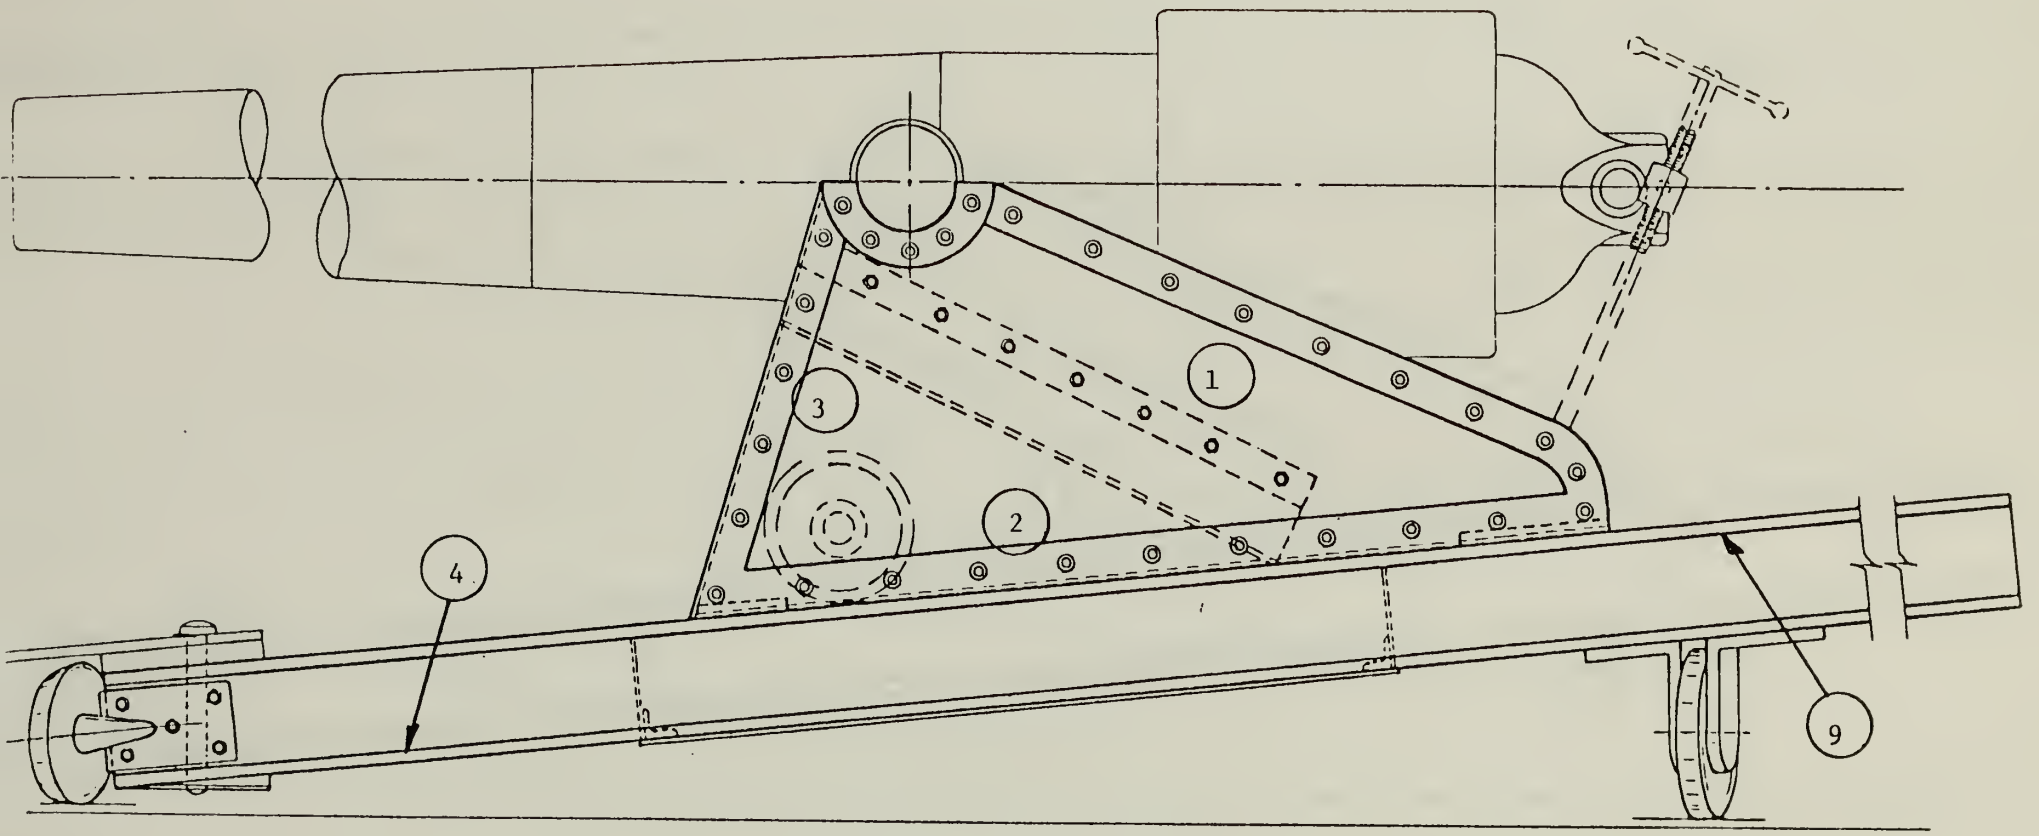
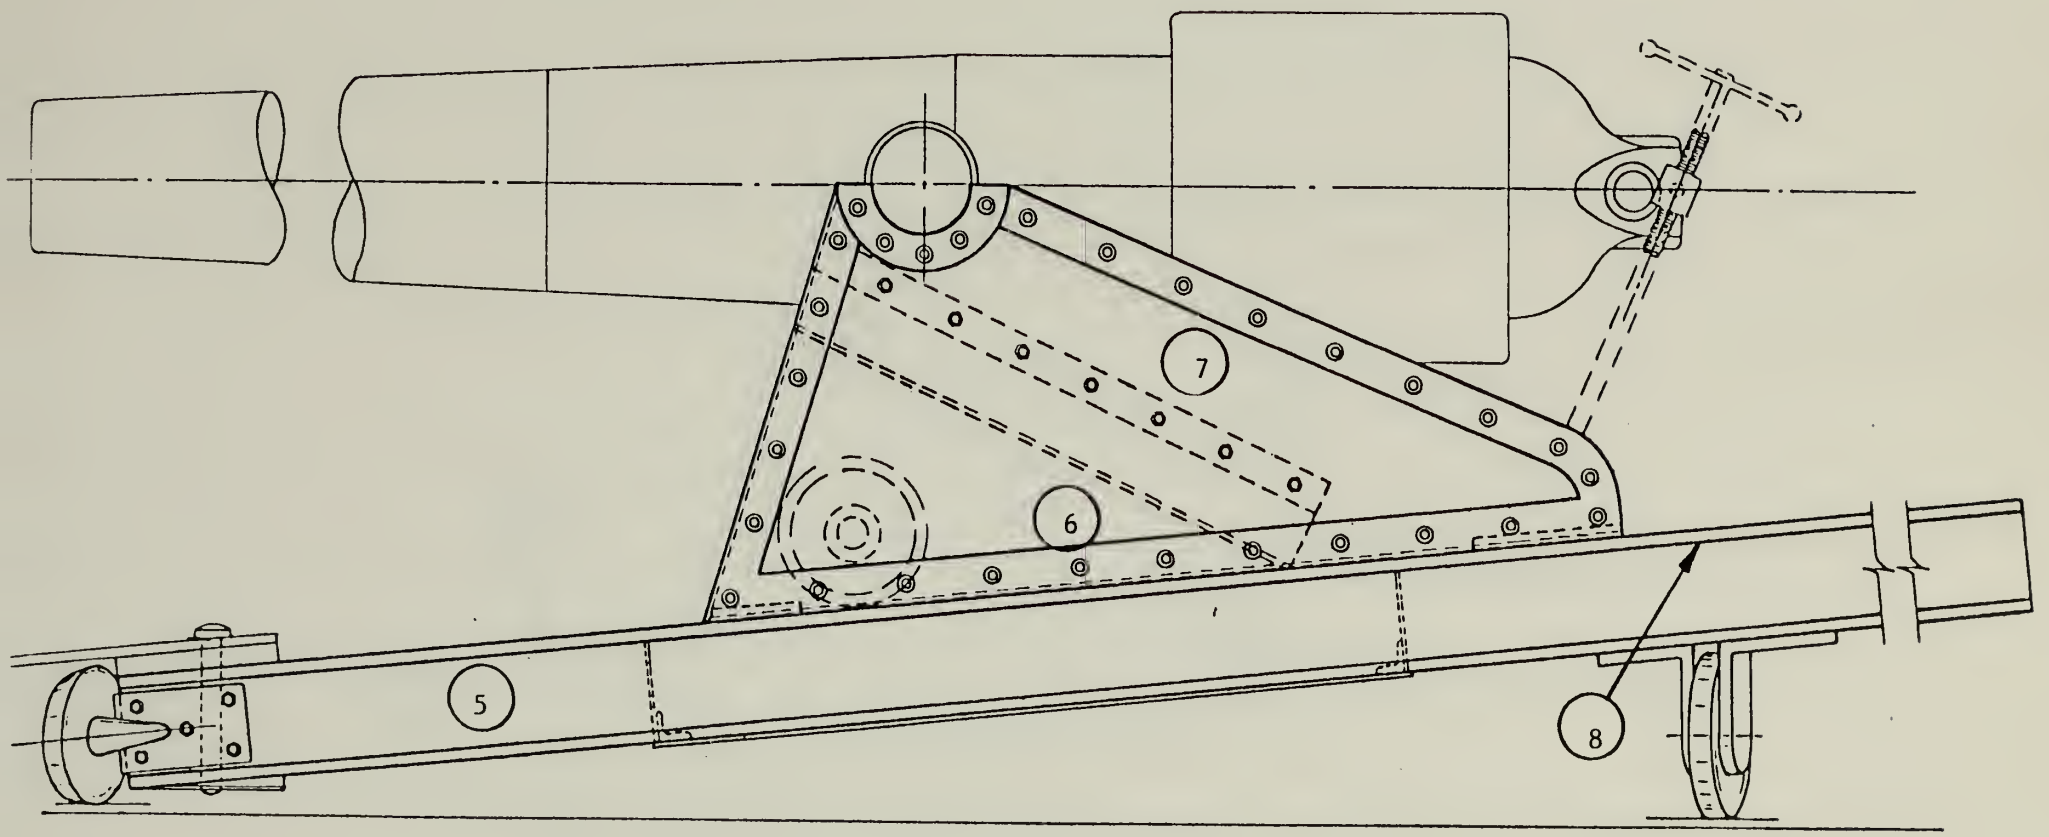
Cannon Number Four

Cannon Number	Remarks
#4 (For film locations refer to enclosed sketches)	1) View 1 reveals one area corroded completely thru parent metal 2) View 2 reveals 3 areas completely thru parent metal. 3) View 3 reveals three small holes completely thru parent metal. 4) View 4 reveals 2 areas almost thru parent metal. 5) View 5 reveals one area almost thru parent metal. 6) View 6 reveals several areas rusted thru parent metal as marked on radiograph. 7) Views 8 & 9 reveal areas of in-line Inclusions that appear to be separations of metal.

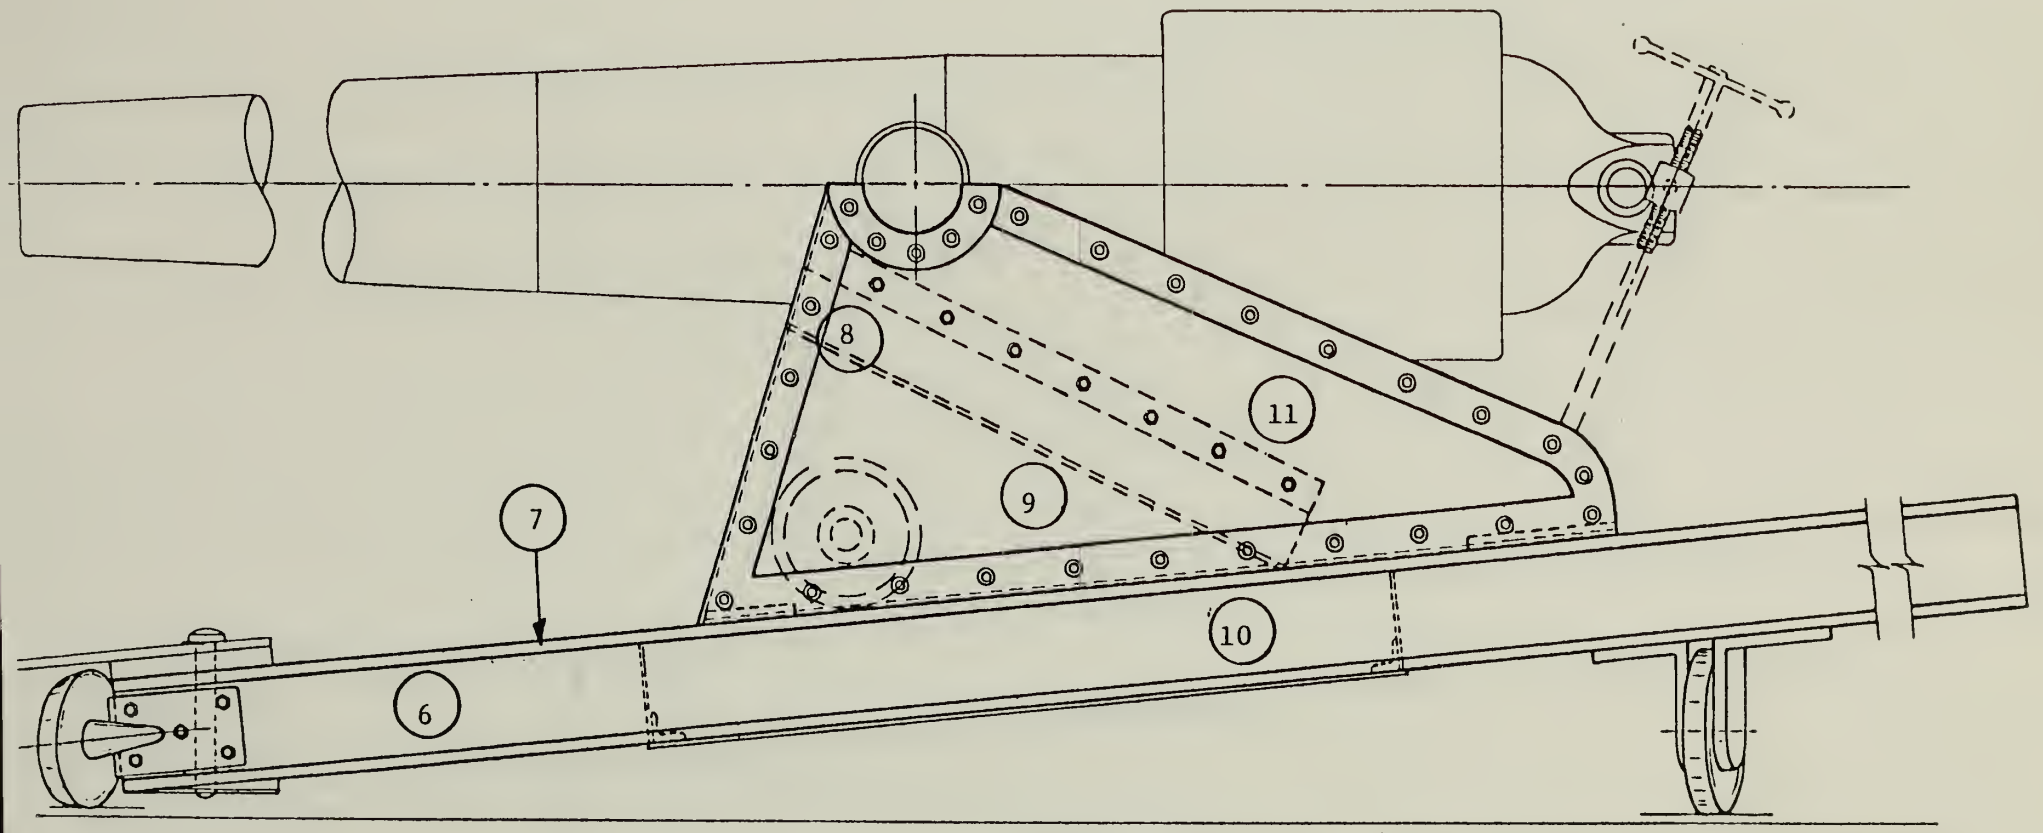
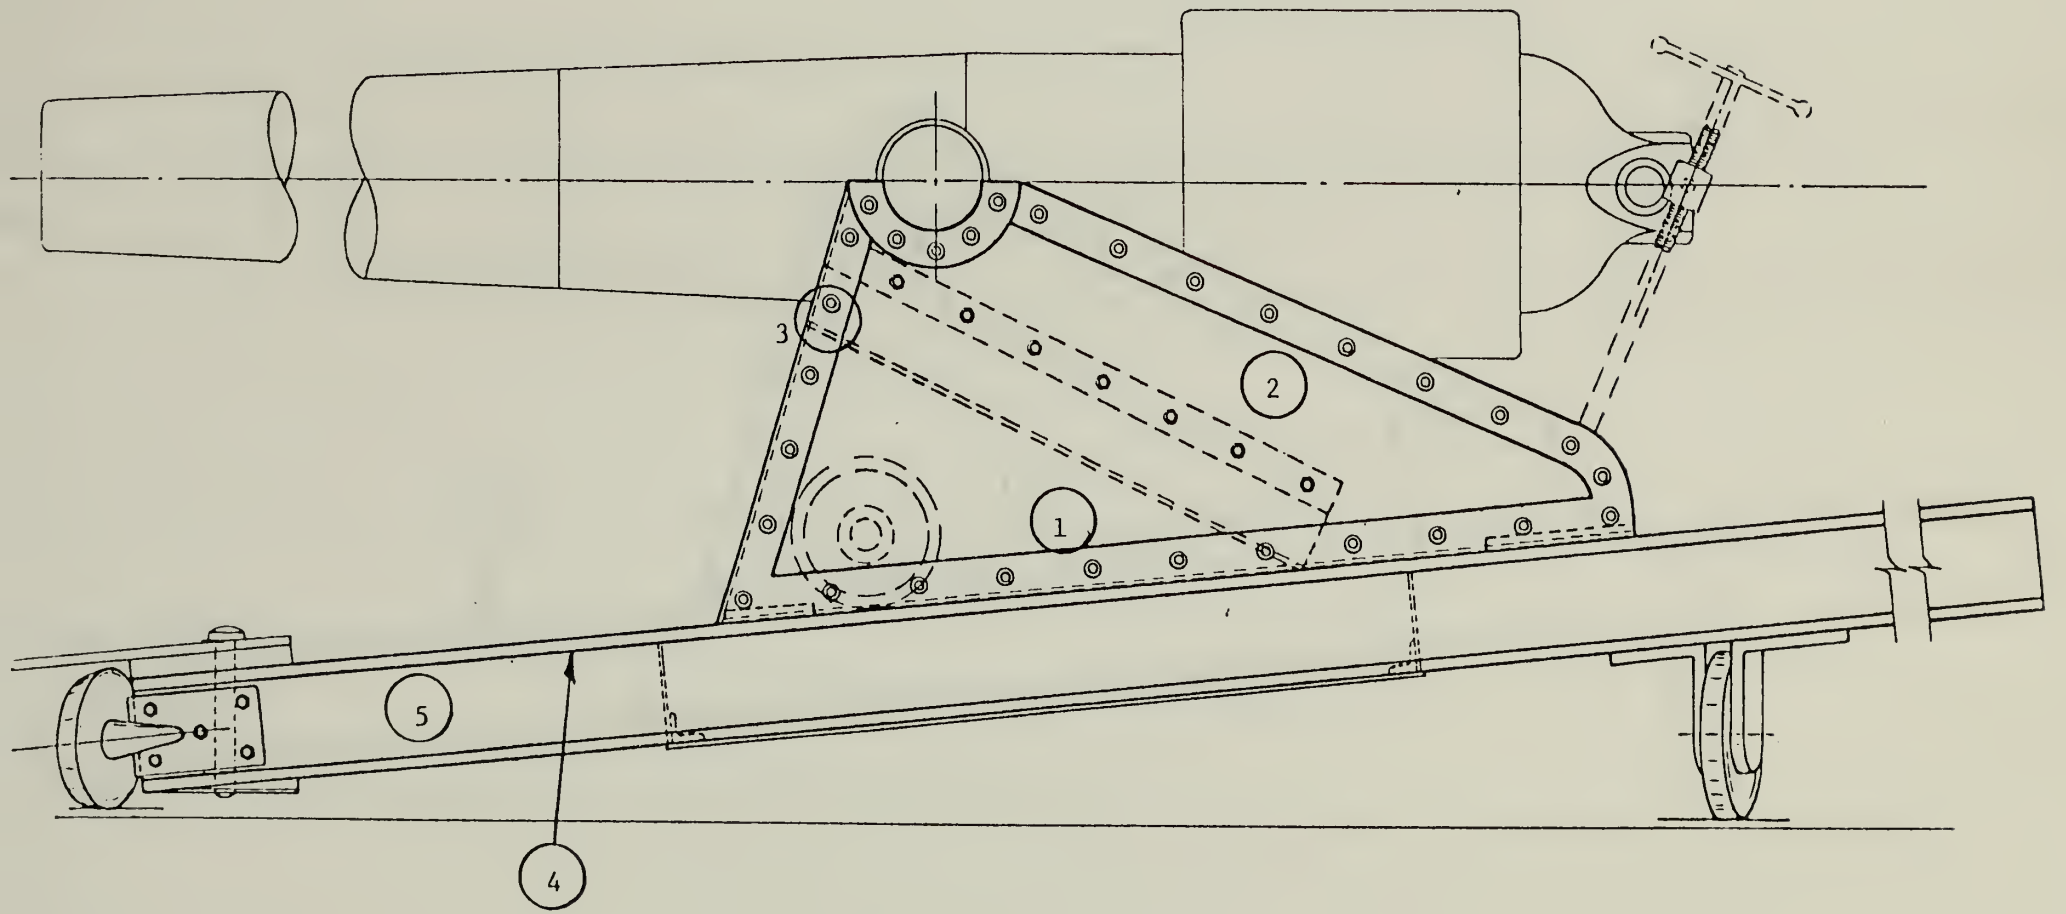
Cannon Number Five

#5 (For film locations refer to enclosed sketches)	1) View 1 reveals heavy corrosion with several areas rusted completely thru. 2) Views 2 & 3 also reveal heavy corrosion and rust with several areas completely thru parent metal. 3) View 4 indicates an in-line indication that appears to be seperation of parent metal. 4) View 5 reveals heavy corrosion and rusting with one area rusted completely thru. 5) View 7 indicates in-line indications that appear to be seperation of parent metal. 6) View 8 reveals heavy corrosion and rusting with one area completely thru. 7) View 9 reveals gross corrosion and rust with crack indications. 8) View 10 reveals heavy corrosion with cracks. 9) View 11 indicates heavy corrosion and rust with several areas rusted thru.

The face plate was a 1/2" thick plate of wrought iron. All face plates of the eleven cannons are severely deteriorated. The worst condition existed in cannon No. 5, where the side plates are rusted through with small holes. About 60% of the thickness of the plates were rusted, pitted and flaked away.

The carriage beam is a 9" I beam of wrought iron. The flange averaged 1" thick and the web 5/8" thick when new. The severest rust occurs at cannon No. 5, where 50% of the base metal has been rusted away.

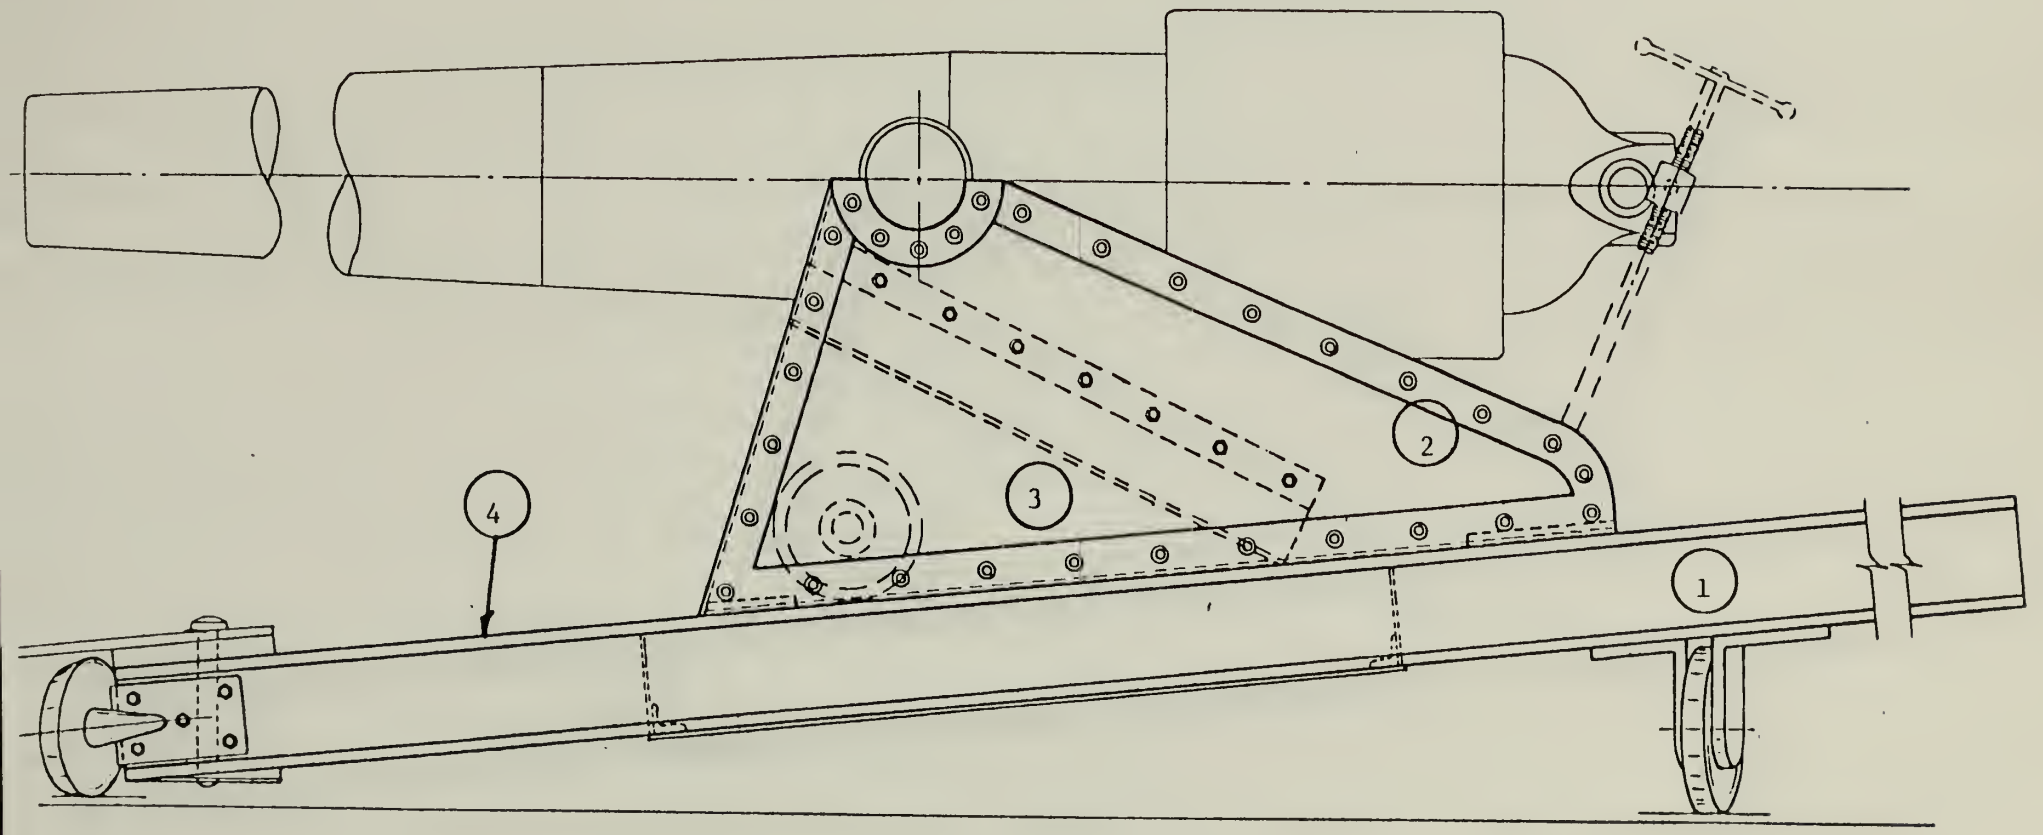
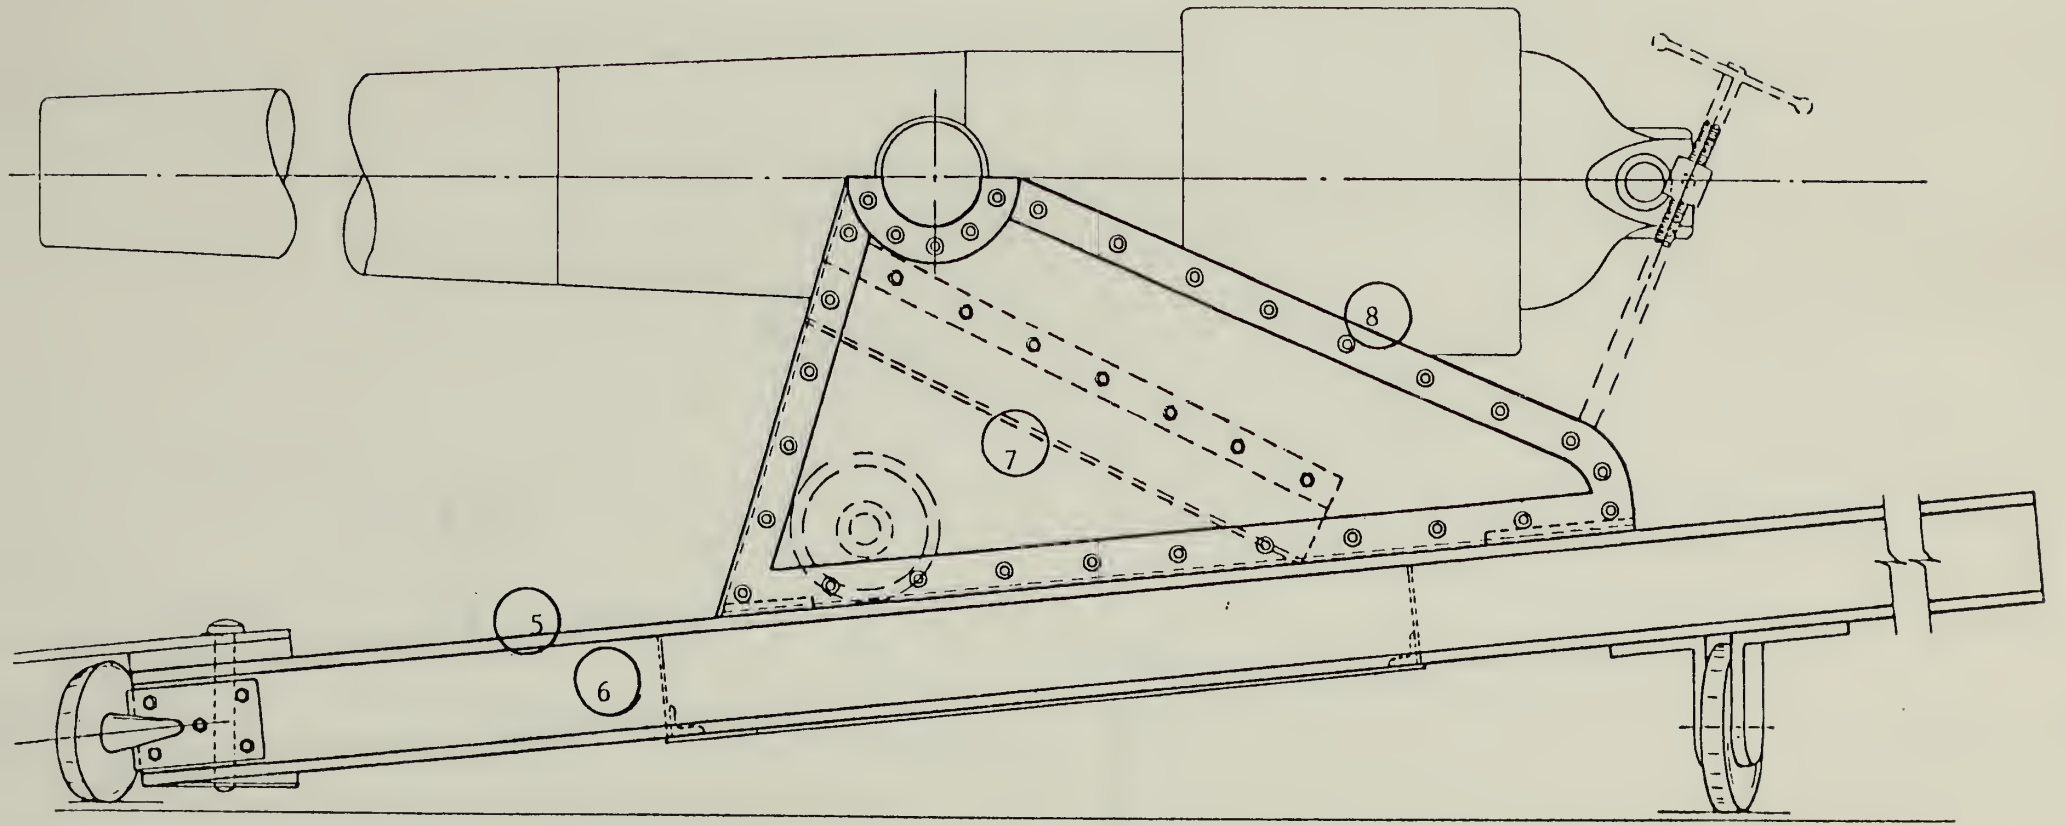
Cannon Number Six

Cannon Number	Remarks
#6 (For film locations refer to enclosed sketches)	1) Entire inspection area revealed heavy corrosion and rusting with numberous area: rusted thru parent metal. 2) Views 4 & 5 reveal in-line indications that appear to be seperation of parent metal. 3) View 8 reveals cracking indications as marked on radiographs.

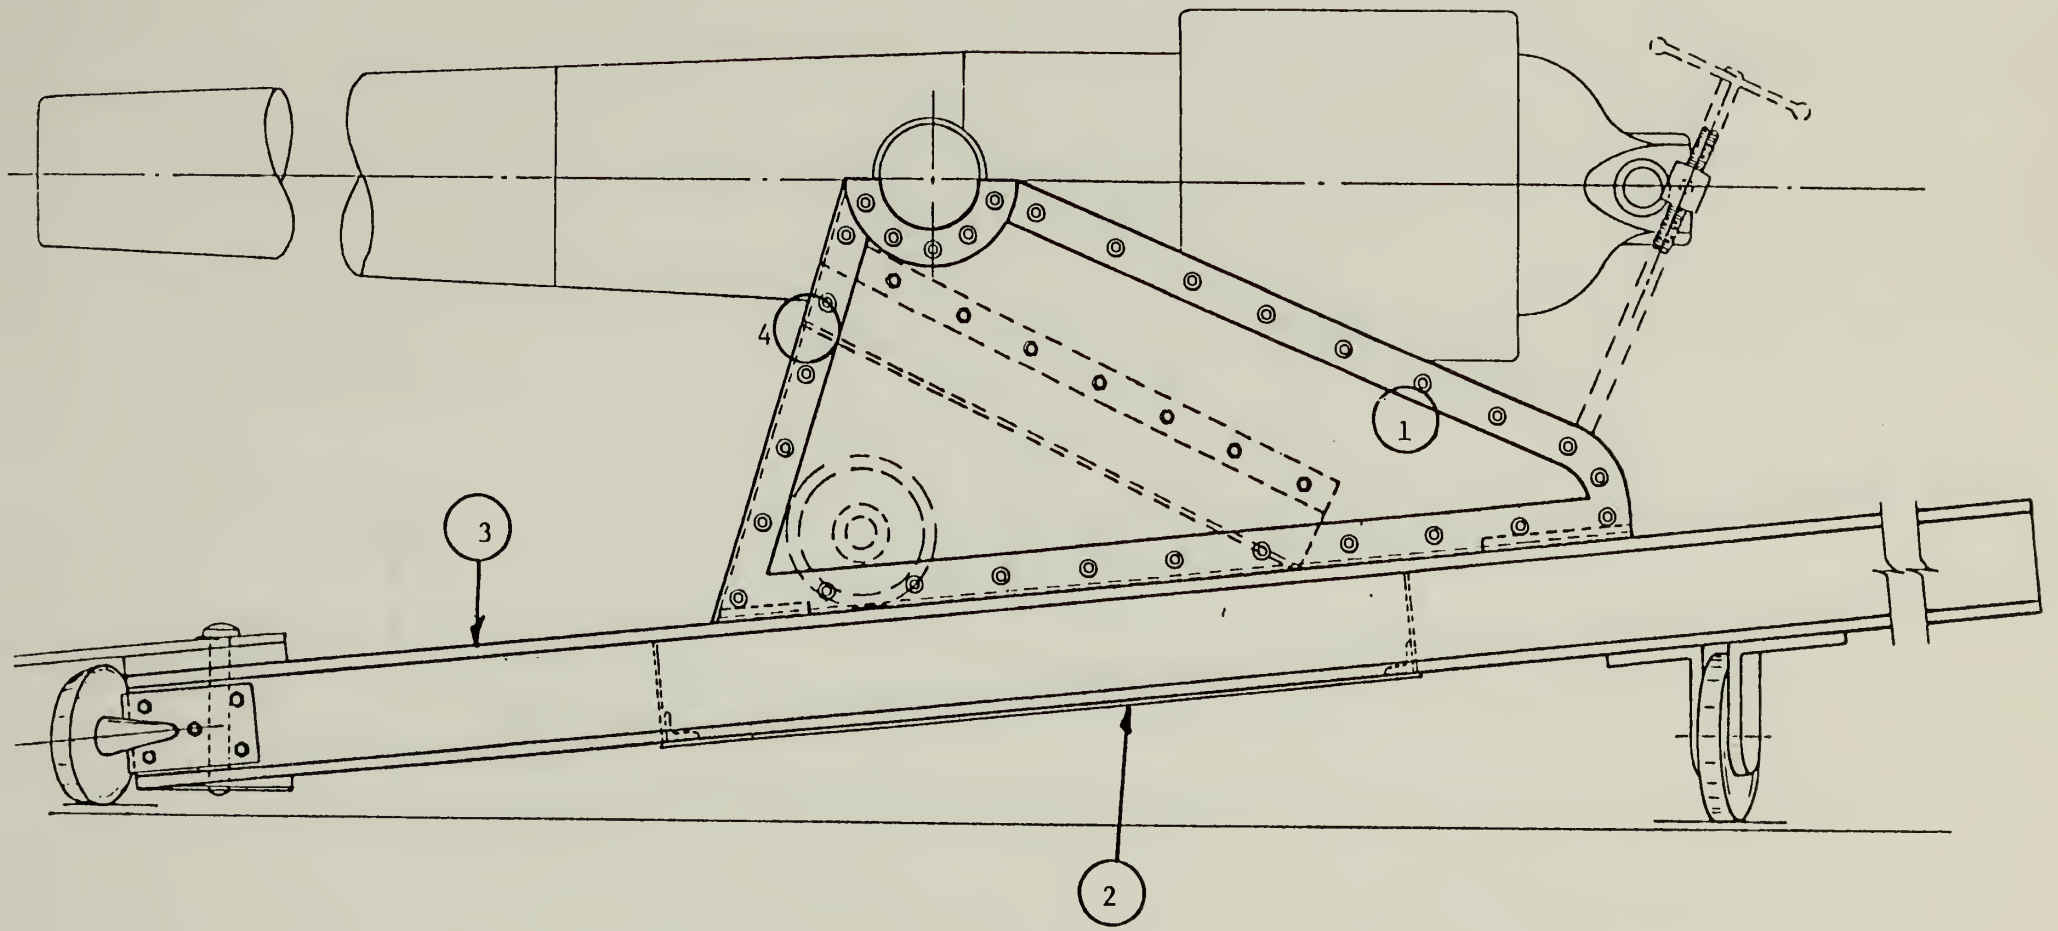
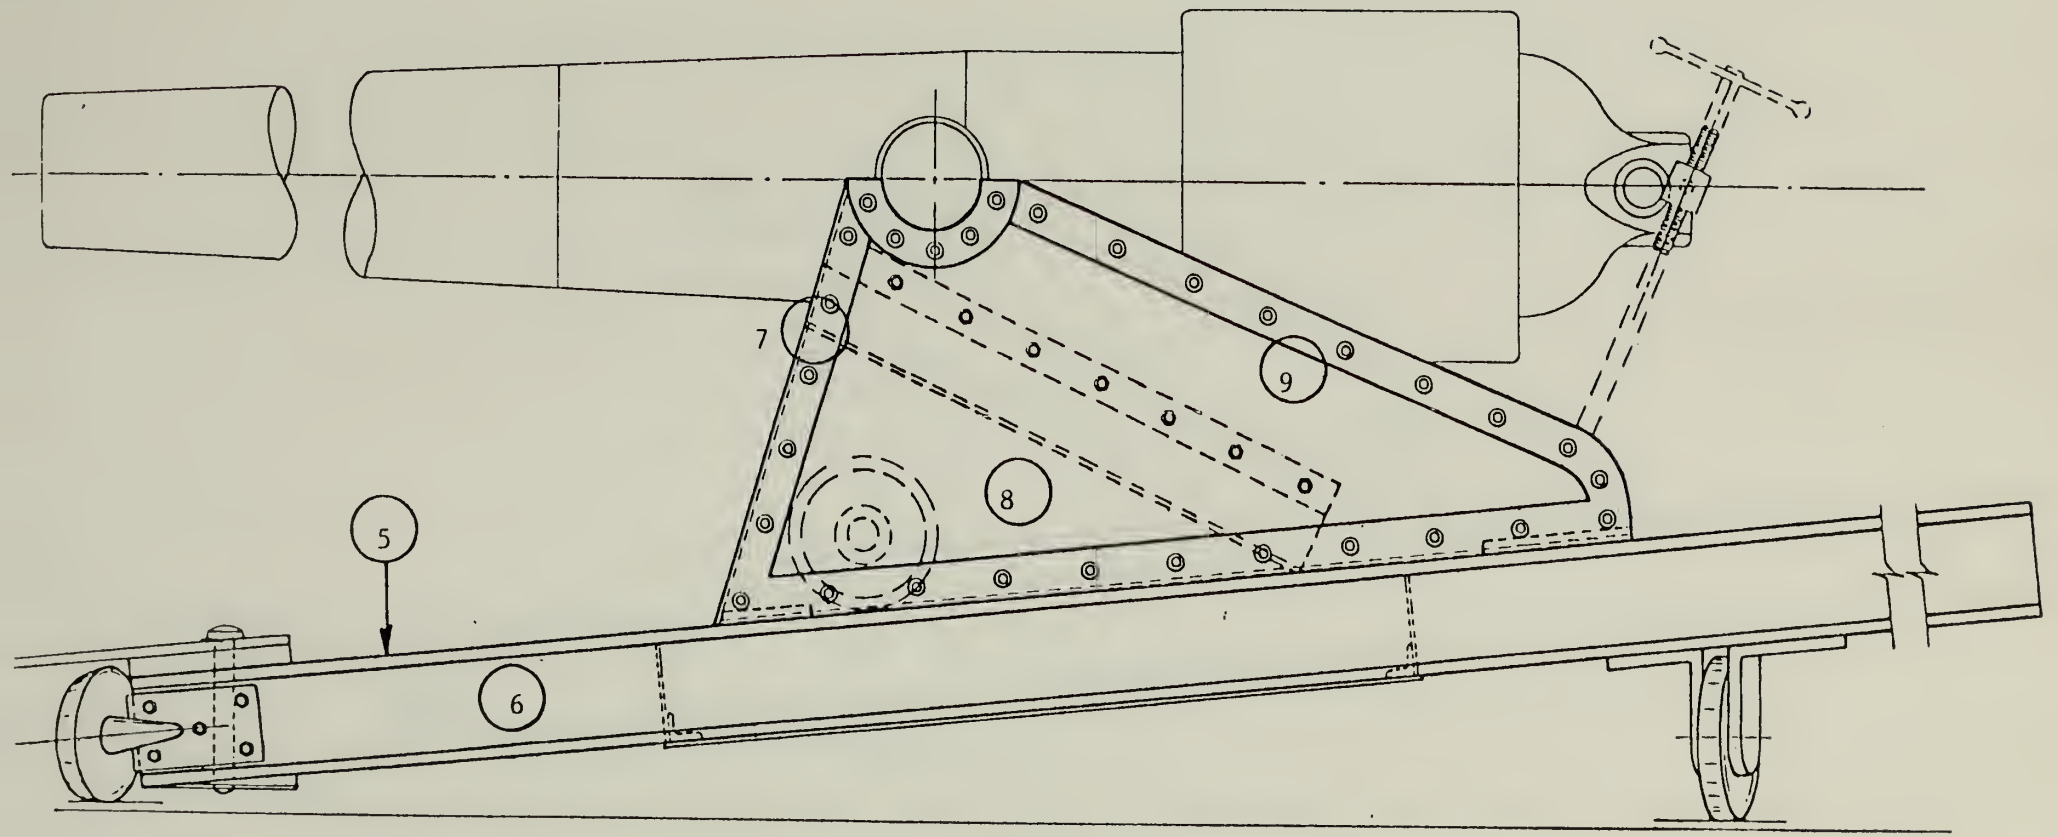
Cannon Number Seven

#7 (For film locations refer to enclosed sketches)	1) Views 3 & 5 reveal in-line indications with possible cracking. 2) Views 8 & 9 reveal heavy corrosion and rusting.

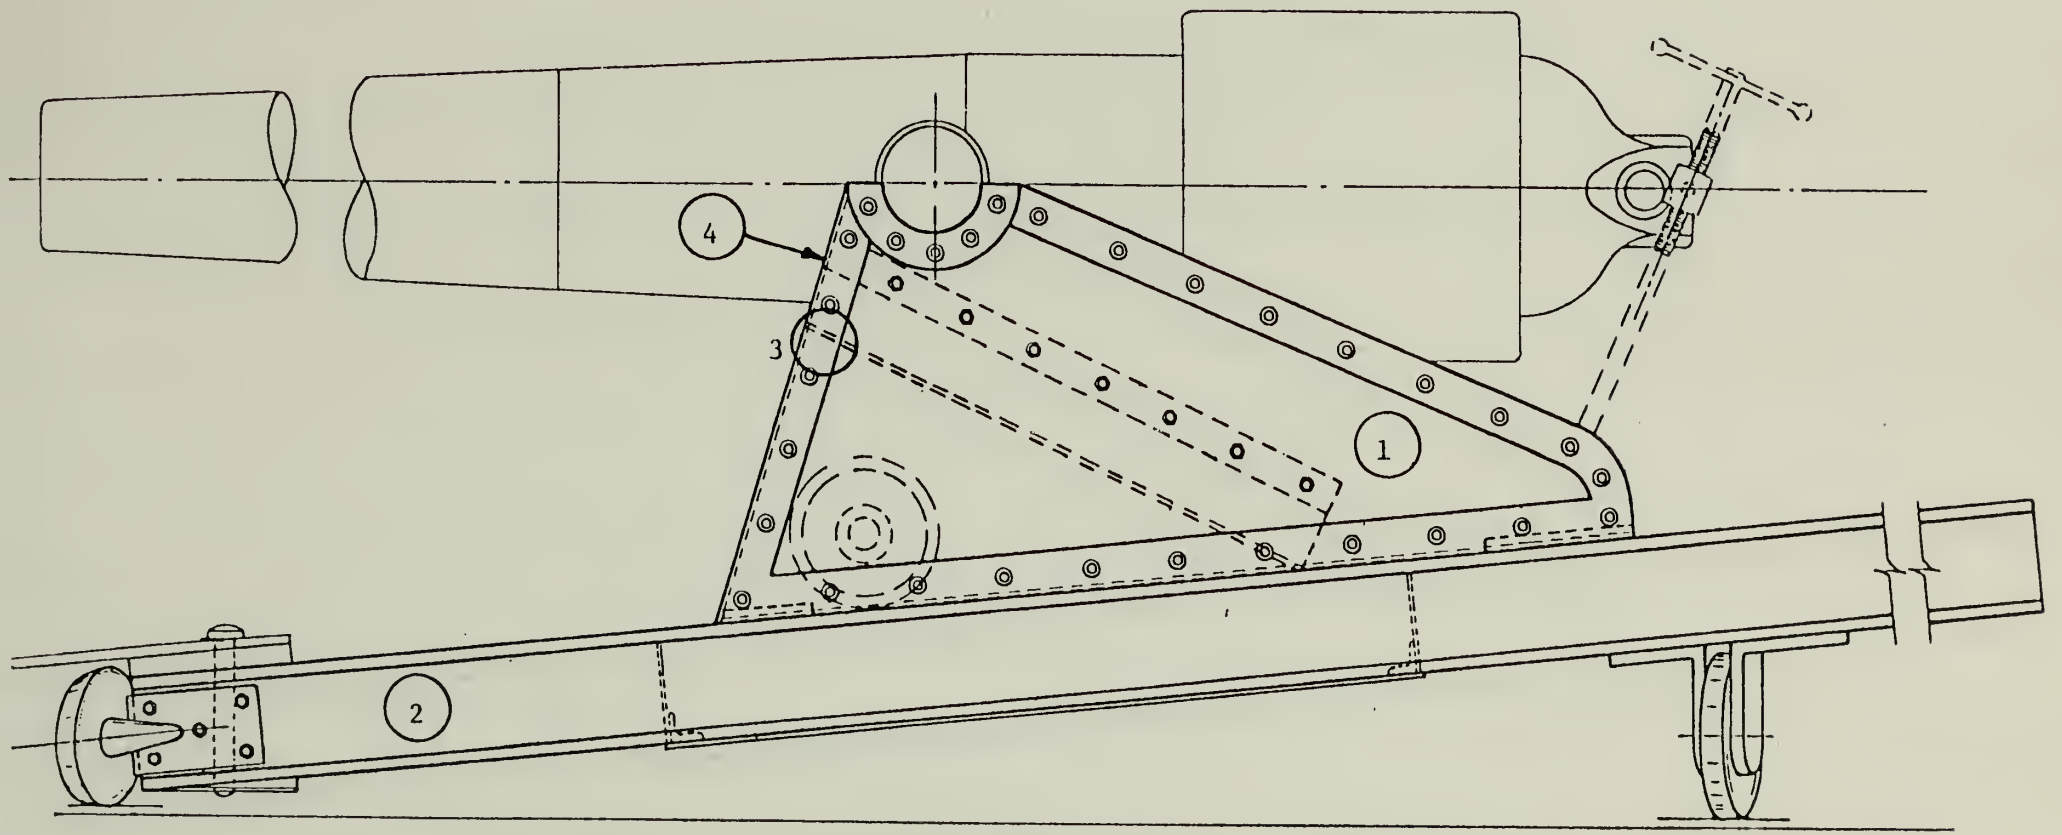
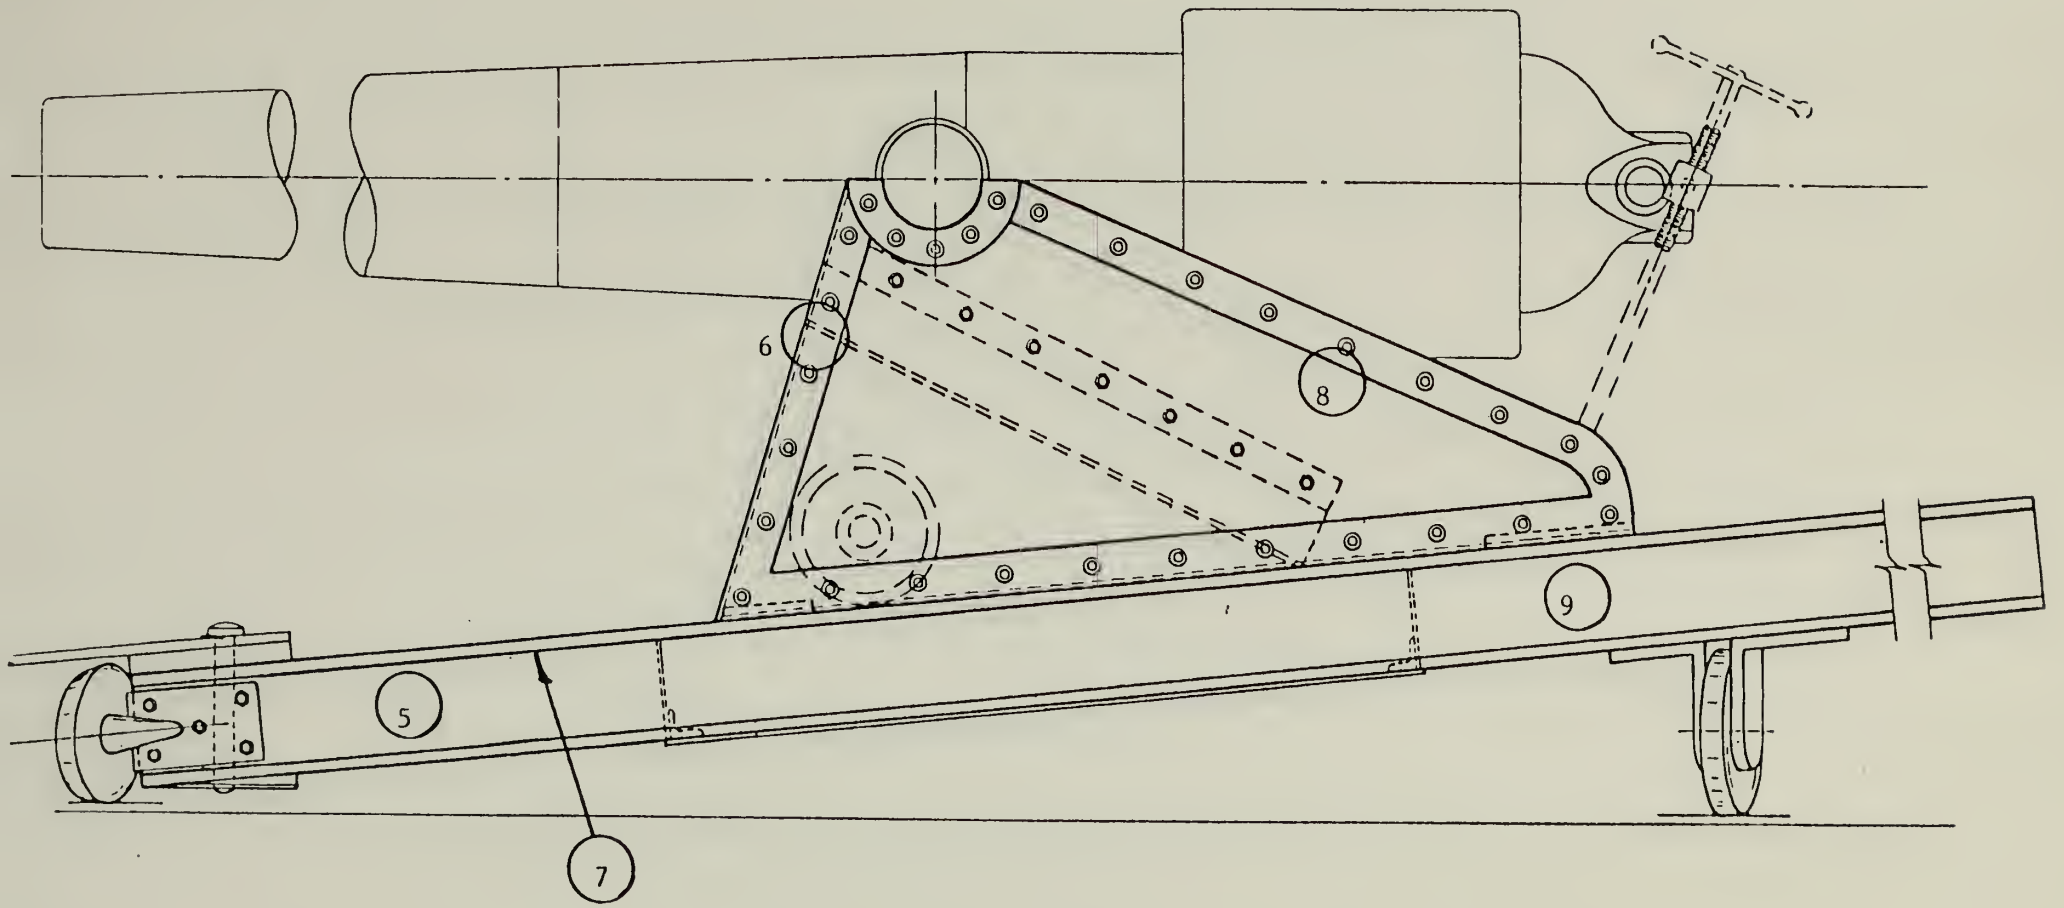
Cannon Number Eight

#8 (For film locations refer to enclosed sketches)	1) Entire inspection area reveals heavy corrosion, rust and pitting.
#9 (For film locations refer to enclosed sketches)	1) View 5 reveals in-line indications that appear to be seperation or parent metal with possible cracking.

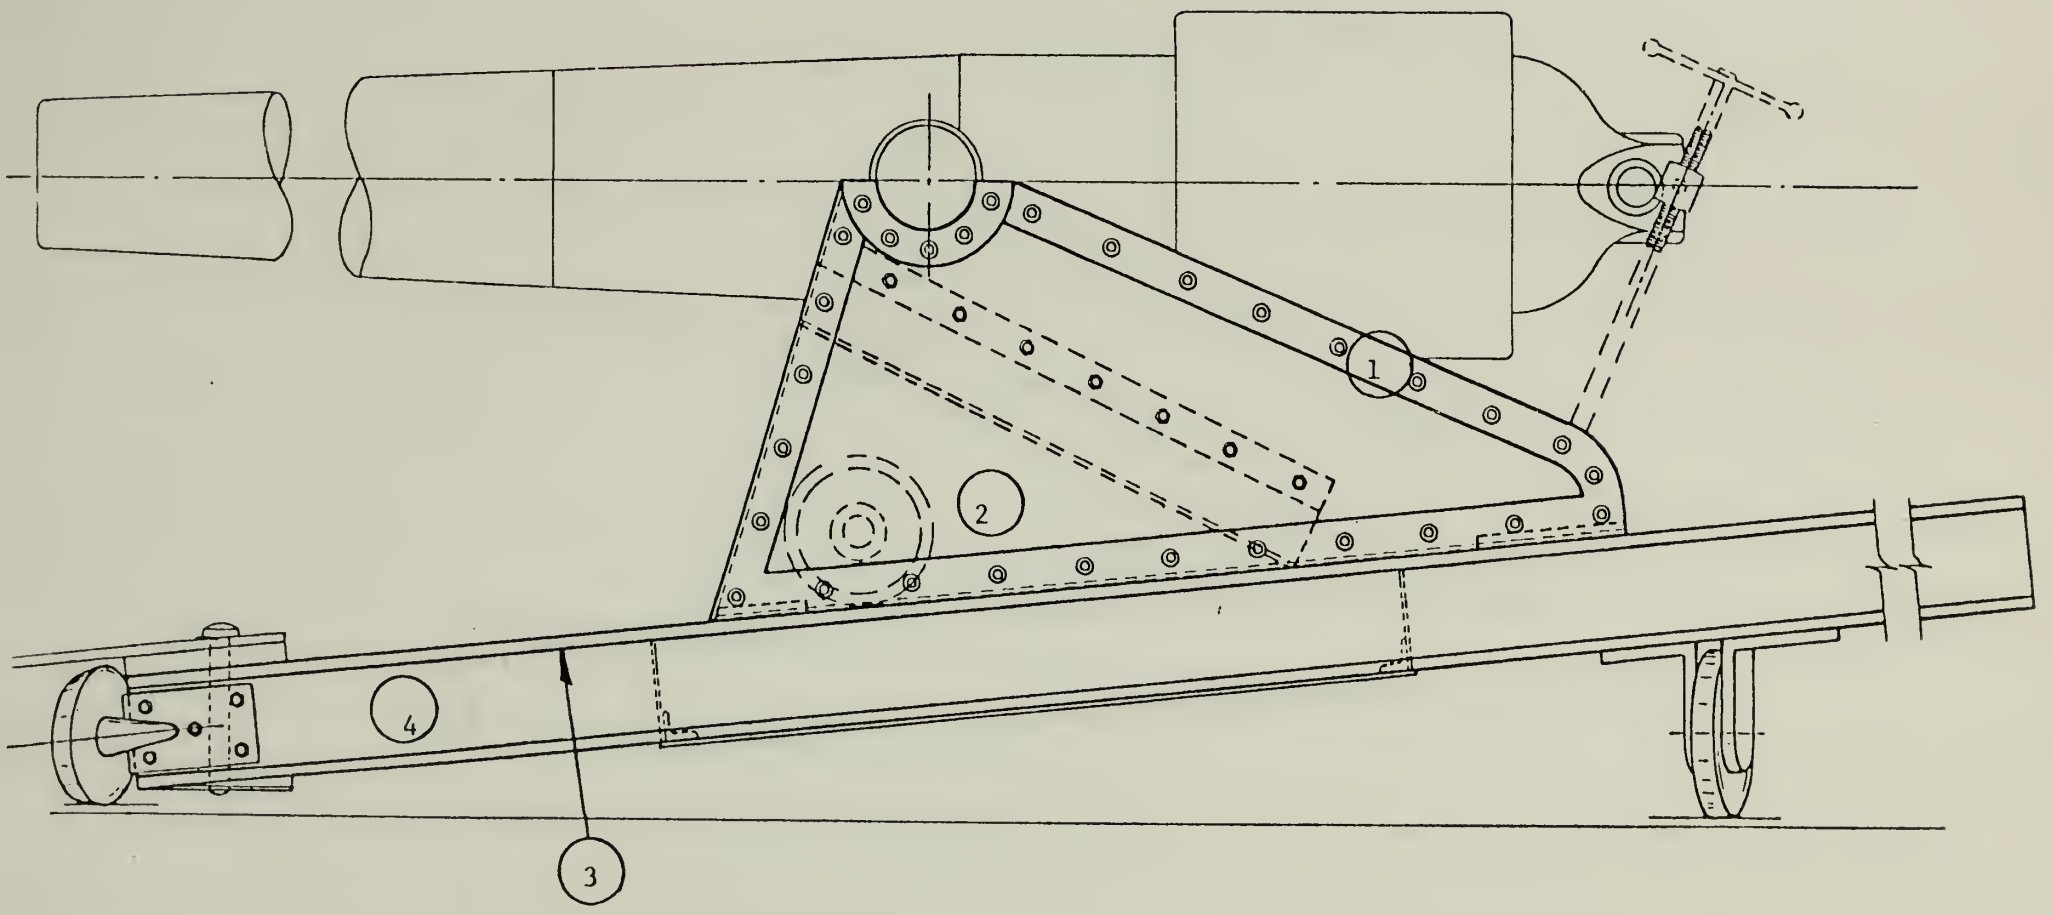
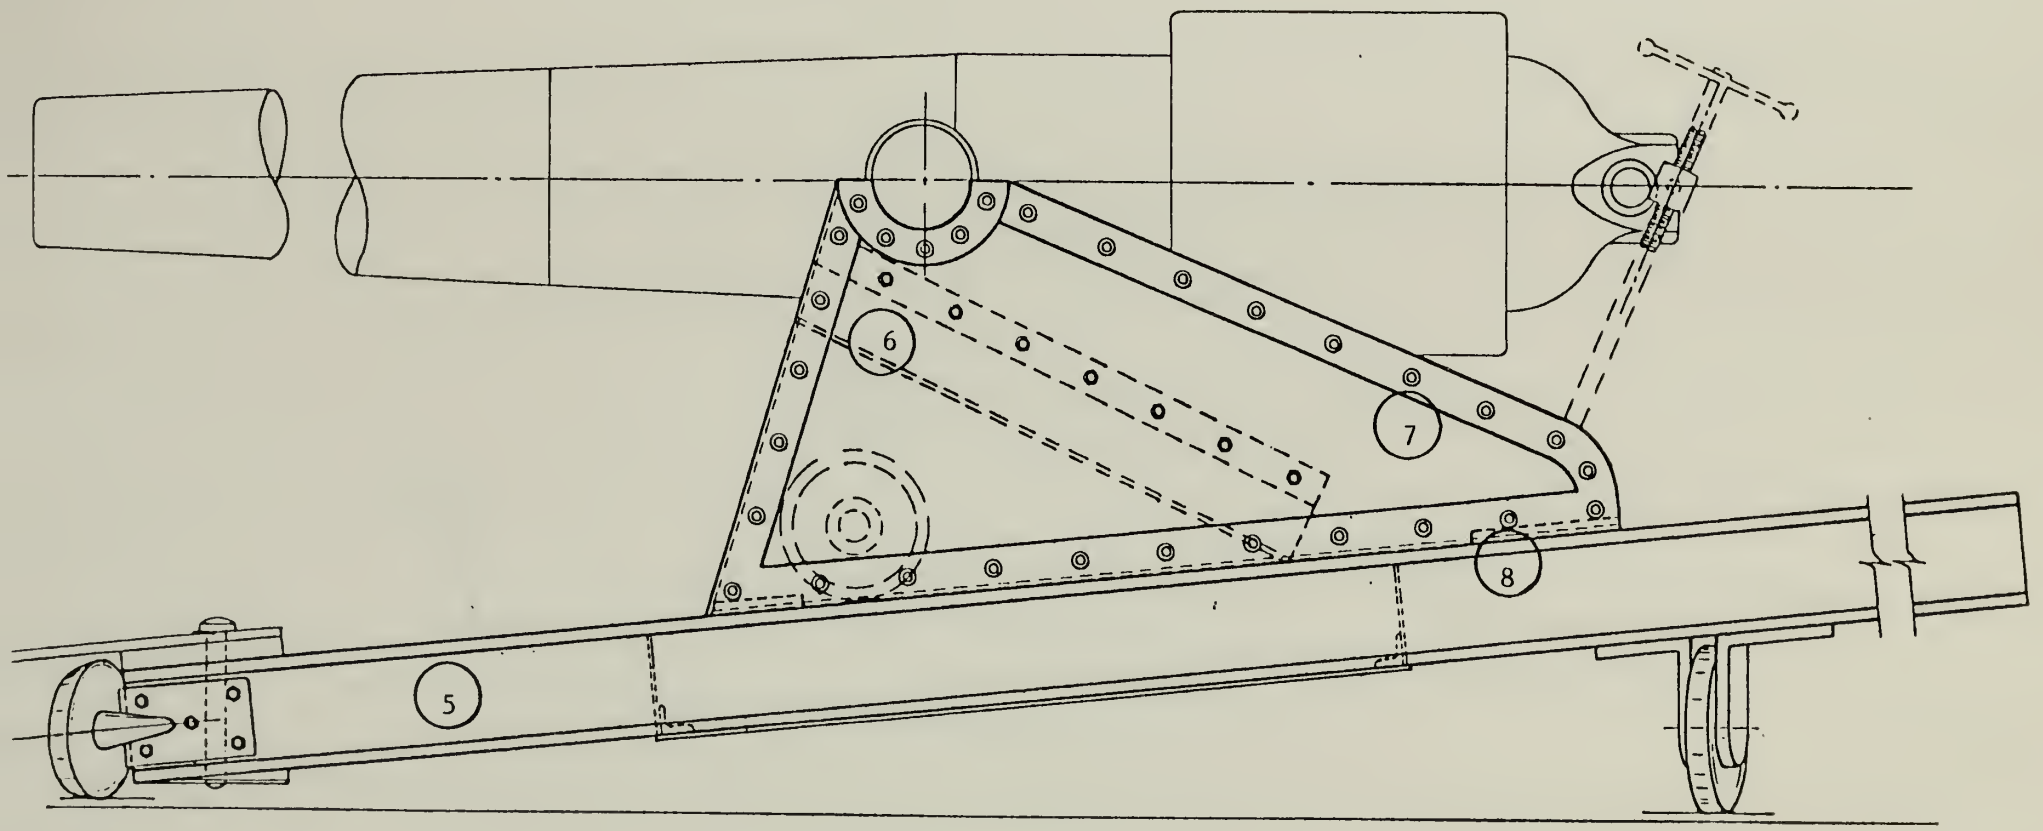
Cannon Number Ten

#10 (For film locations refer to enclosed sketches)	1) View 3 reveals in-line indications that appear to be seperation and cracking. 2) Views 7 & 8 indicate heavy corrosion and rusting with several areas rusted almost completely thru parent metal. 3) View 8 reveals excessive wear but appears to be from normal use.
